RICS Home Surveys Building Survey

Property address

Date of inspection

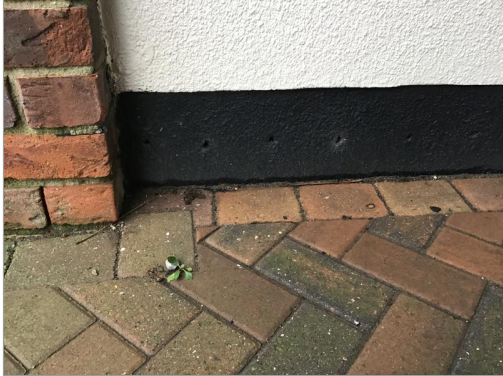
Moisture readings were taken with an electronic damp meter at regular intervals. I have recorded high damp meter readings to some of the walls at ground floor level. It would appear that damp proofing work is necessary. Please see section F3.

Photo - 3 Evidence chemical DPC

You should instruct your own specialist damp proof contractor issuing a long term guarantee to carry out a full inspection of the property and to implement all necessary remedial works. In conjunction with the above, damp affected plaster should be replaced in accordance with the specifications of the specialist contractor. Failure to do so may nullify the guarantee. Please see section E4, F3 & J).

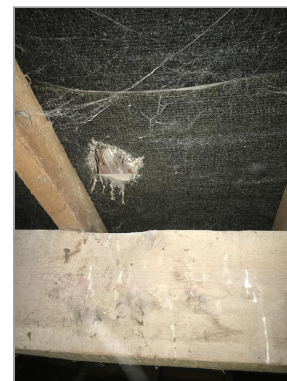
The roof under lining has perished, is torn and is holed in several areas. Without an effective lining there is a risk of wind-blown rain penetration occurring that could cause damage. The lining should be repaired or replaced in these areas.

Photo - 5 Hole in felt

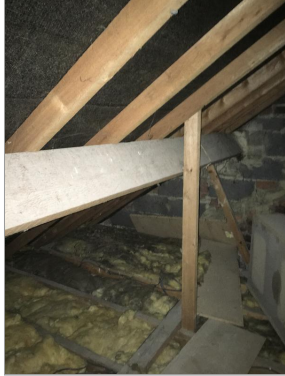
Photo - 6 Purlin and strut support

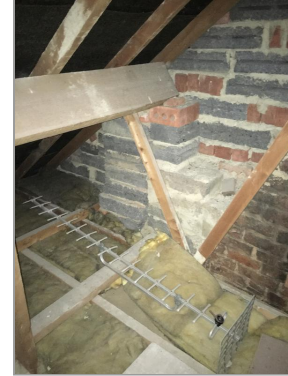
Photo - 7 Purlin built into party wall

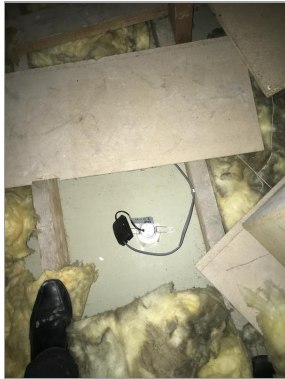
Insulation should not be laid over recessed ceiling lighting in the roof space (see photo), to reduce the risk of overheating and fire. Where covered, the insulation should be removed and re-laid in accordance with the recommendations of the lighting manufacturers.

Photo - 8 No insulation over lighting

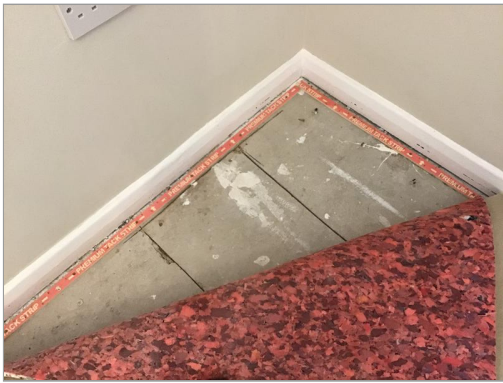
Photo - 10 Chipboard flooring

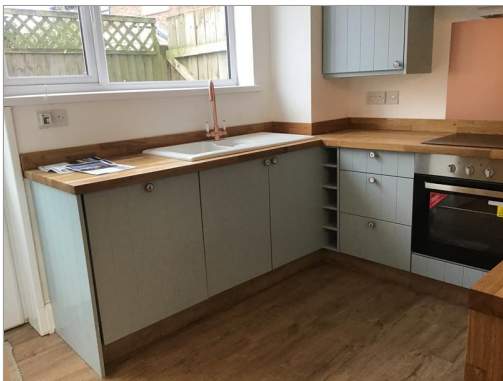
Photo - 11 Kitchen base units

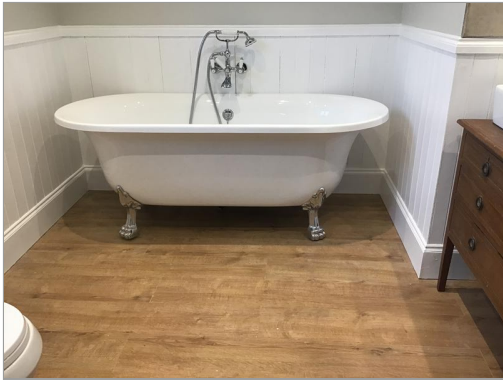
Photo - 12 Freestanding bath

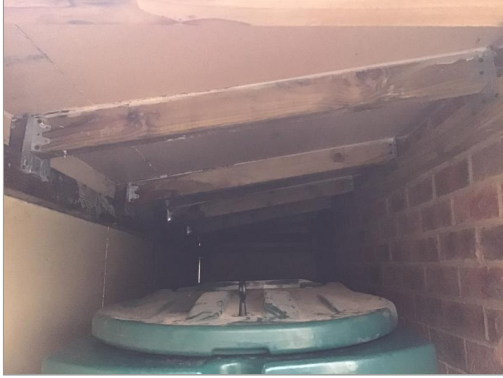
Photo - 13 Oil tank

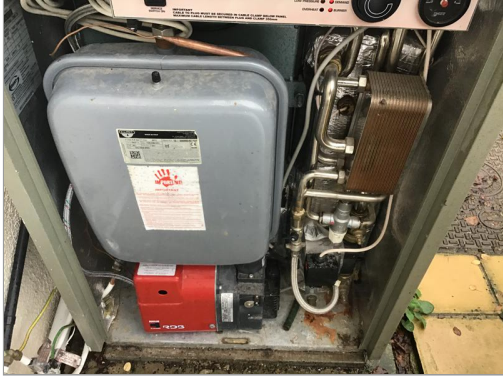
Photo - 14 Boiler

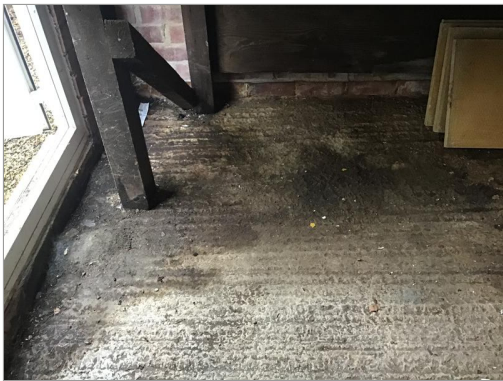
Where visible and from the limited inspection, the internal wall and floor surfaces appeared to be in satisfactory condition. However water staining was present on the floor, this is likely caused by the adjoining high ground level. The ground level should be lowered.

Photo - 15 Damp in garage floor
