RICS Home Surveys Building Survey

Property address

Date of inspection

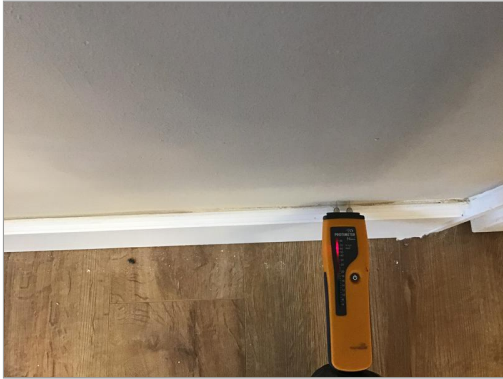
Photo - 9

The inspection of the floors was severely restricted by fixed floor coverings throughout and I cannot confirm that they are all free from defects. We have not inspected the sub-floor joists.

The floors were found to be generally level and firm, there are no indications to suggest serious defects. However, when coverings or boards are lifted defects may become apparent (particularly in older properties).

The ceramic tiles which have been laid on the timber floor in the en suite will crack when the floor naturally flexes.
